NAVAL POSTGRADUATE SCHOOL

A SCANNING ELECTRON MICROSCOPE STUDY
OF THE CORROSION OF SACRIFICIAL HULL
ANODES UNDER SIMULATED SHIP SERVICE CONDITIONS

December 1976

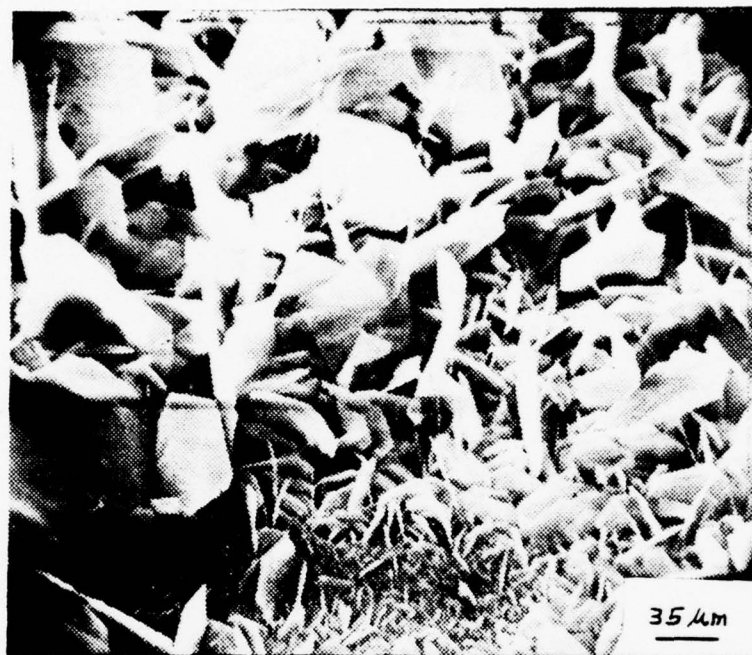
Figure 12

Zinc anode surface after 4
days static exposure, 260X
(4DZ3)

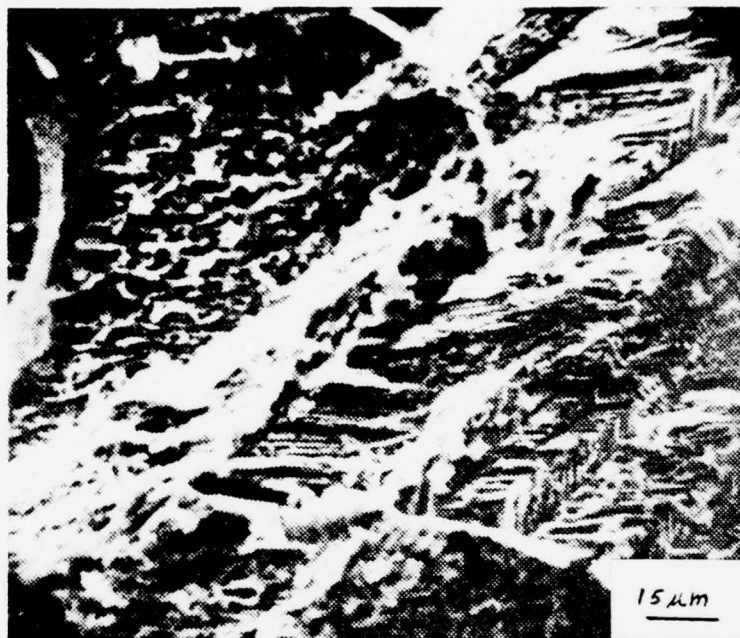
Figure 23

Zinc anode surface after 8 days static exposure
and rinsing away of corrosion product, 720X
(8DZ3)

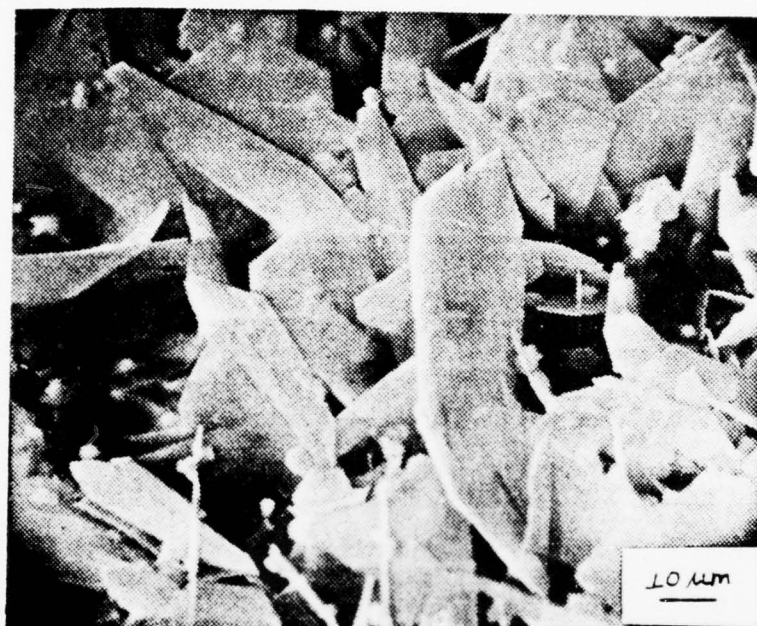
Figure 35

Zinc anode specimen after 12 hour static exposure, 800X (12H23)

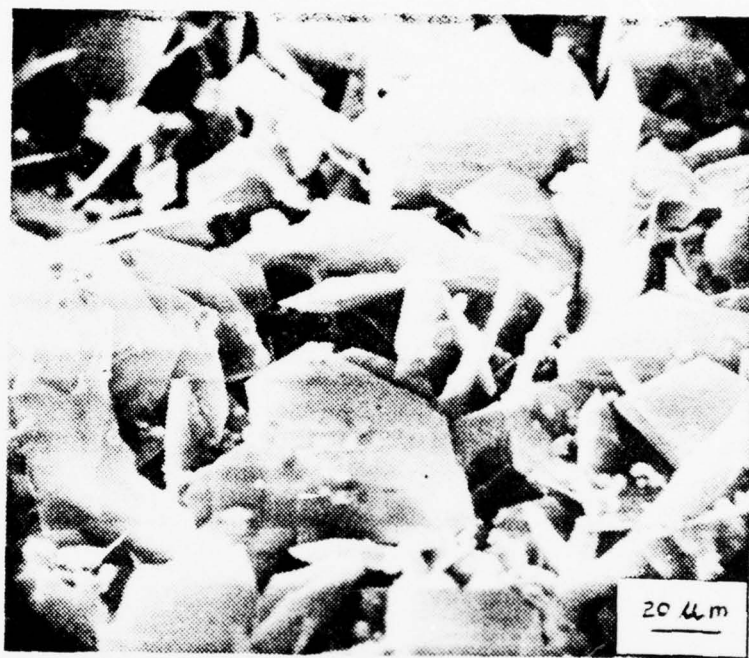
Figure 36

Zinc anode specimen 12HZ1 after 1 hour
dynamic exposure at 150 rpm, 5 mA/in²,
showing lack of reforming and redeposition,
500X

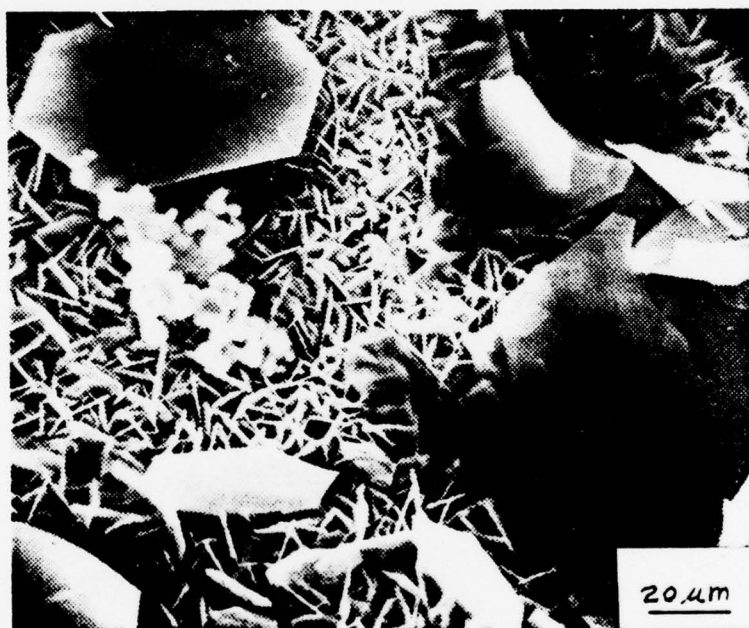
Figure 44

Zinc anode specimen after 36 hour
static exposure, 610X (36H22)

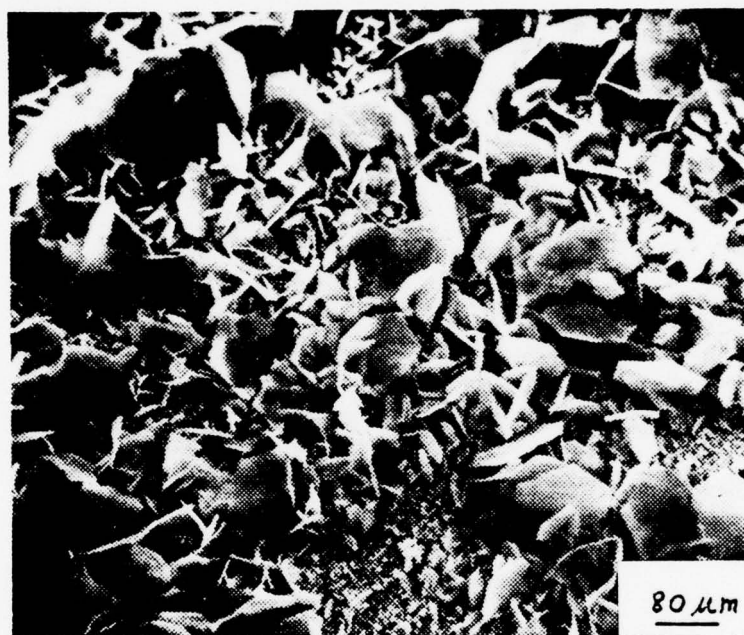
Figure 48

Zinc anode specimen after 2 day
static exposure, 120X (2DZ1)

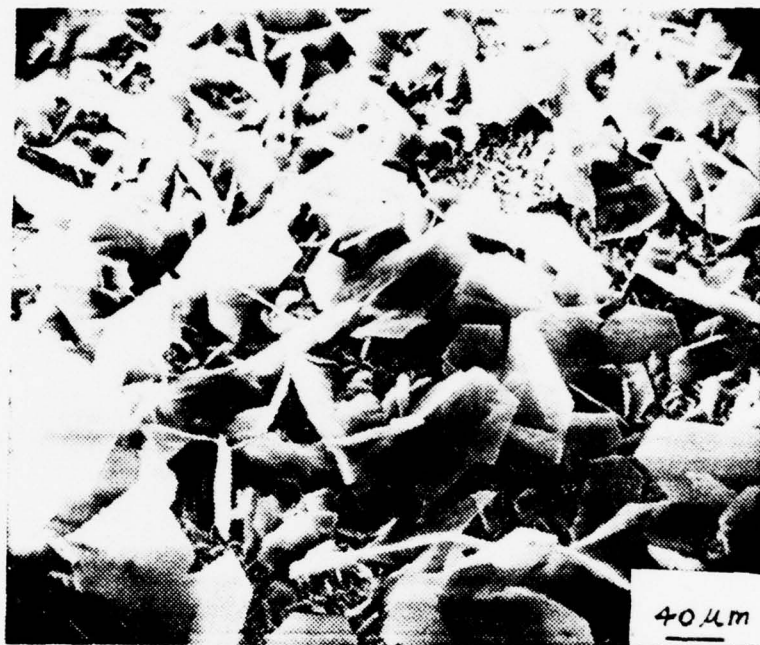
Figure 49

Zinc anode specimen 2DZ1 after 3 hour
dynamic exposure at 100 rpm, 5 mA/in²,
showing lack of reforming and redeposition,
220X

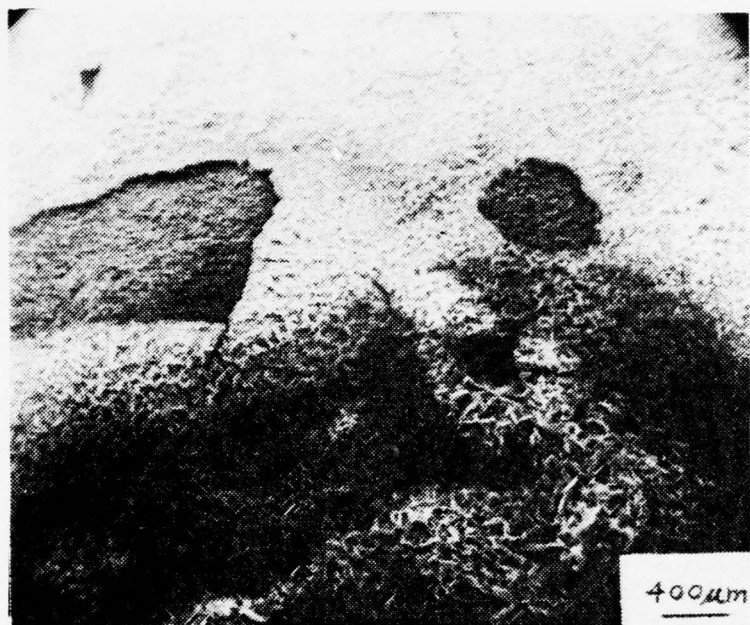
Figure 50

Zinc anode specimen 2DZ1 after 3 hour
dynamic exposure at 100 rpm, 5 mA/in²,
showing areas of platelet removal, 24X

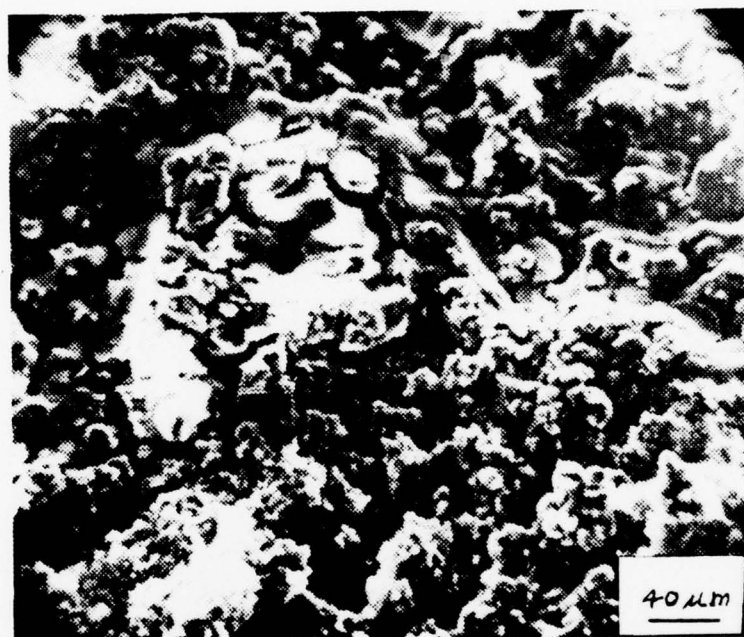
Figure 54

Zinc anode specimen 2DZ3 after 3 hour
dynamic exposure at 100 rpm, 15 mA/in²,
showing the nodular cluster corrosion
product within areas of platelet area
spalling, 260X

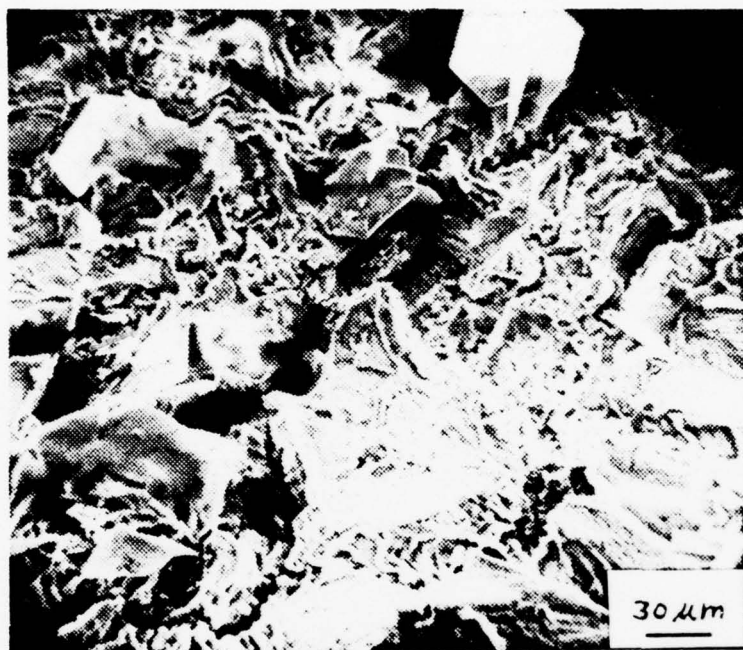
Figure 59

Zinc anode specimen 2DZ2 after 3 hour
dynamic exposure at 50 rpm, 5 mA/in²,
showing platelets reforming into crust
formation, 325X
